**Flood Control Project Maintenance
Levee Inspections**

Fall 2018 Levee Maintenance Deficiency Summary Report

**Flood Control Project Maintenance
Levee Inspections**
LMA District Cover Sheet
Fall 2018 Levee Inspection Results

Reclamation District No. 2060 Hastings

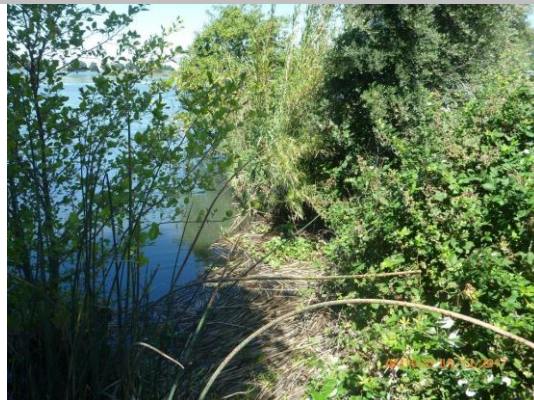
Photo 3 of 6 : FA_2018_RD2060_241_5_20180925_00003.jpg

LM Start	0.40	Rating **	M	Issue No.	5 (cont)	
LM End	0.40	Issue Type +	Ma	Location *	WS	
Category	Supplemental			GPS Latitude/Longitude		
				Start		End
Item	2017 Storm Damage			38.247894 °		38.247911 °
				-121.703492 °		-121.703539 °
DWR ID	DWR_RD2060_01_f _ 2017_5					
Comment Code						
Inspector Comment						
Levee Evaluation Comments						
Description:Erosion commences approximately 3/4 of the way down the slope, near the water line towards the waterside toe.						
Site ID No:358						
Site Designation:LMA-185						
Repair Type: Erosion						
Rating:Area of Concern						
Field Date:7/12/2017						
Notes: Small erosion into bank.

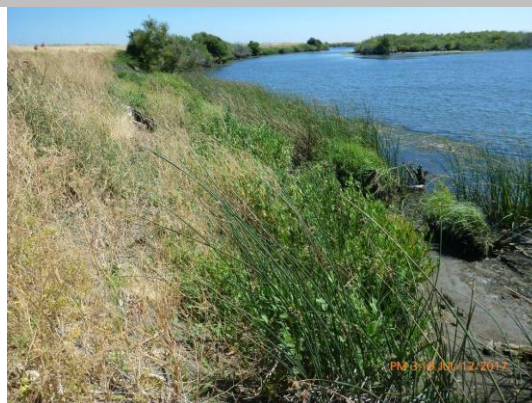
LM Start	1.81	Rating **	A/W	Issue No.	21
LM End	1.84	Issue Type +	Ma	Location *	WS
Category	Supplemental			GPS Latitude/Longitude	
				Start	End
Item	2017 Storm Damage			38.255972 °	38.256247 °
				-121.724197 °	-121.724464 °
DWR ID	DWR_RD2060_01_f_2017_21				
Comment Code					
Inspector Comment					
Levee Evaluation Comments					
Description:Erosion commences approximately halfway down the water side slope extending to the toe. Some slipping into the toe has occurred due to deep erosion.					
Site ID No:366					
Site Designation:LMA-193					
Repair Type: Erosion					
Rating:Serious					
Field Date:7/12/2017					
Notes: Erosion extends halfway into the slope.

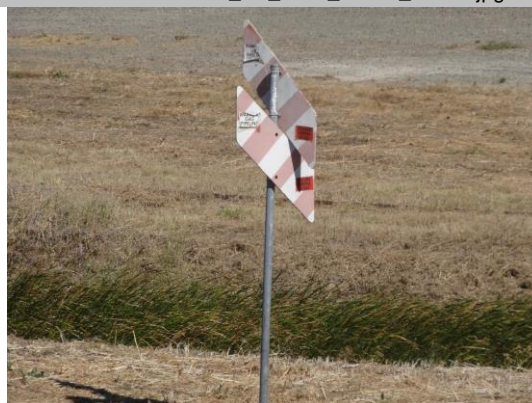
LS view: gasoline indicator across the road from levee toe.

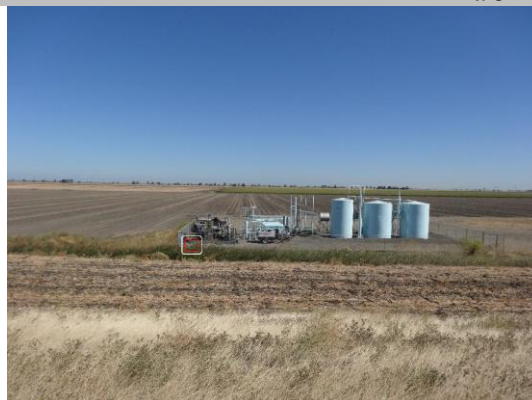
LS view: a gas plant and gasline indicator found on LS.

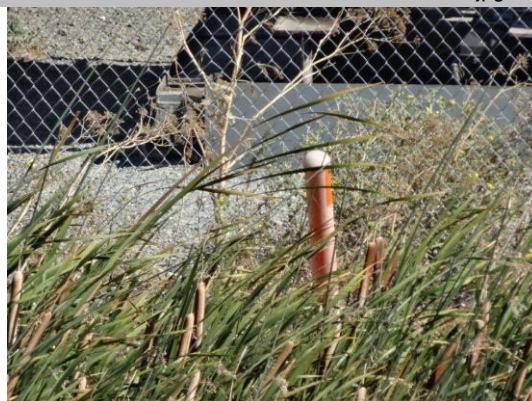
LS view: closer view of gasline indicator found on LS.

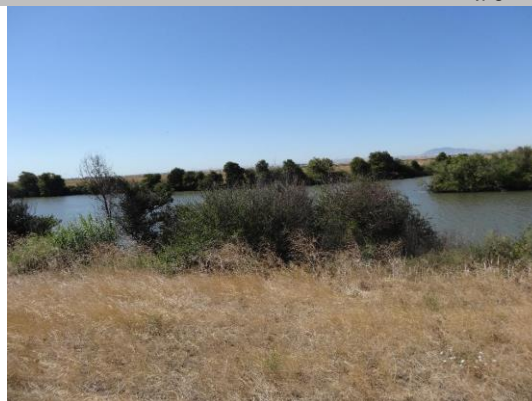
WS view: no indicators found on WS.

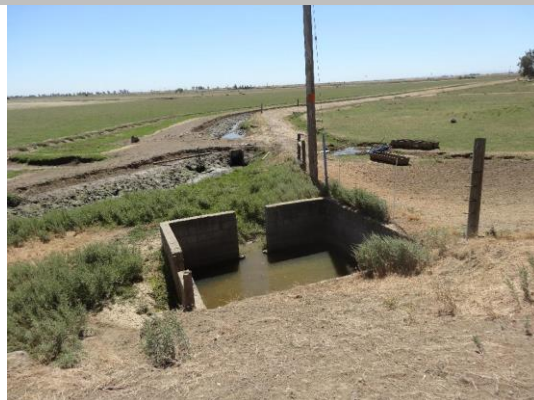
LS view: abandoned concrete distribution box. Not accessible due to wire fence.

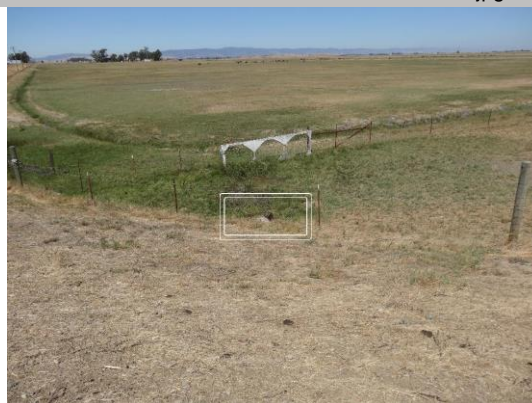
WS view: overview of CMP from levee.

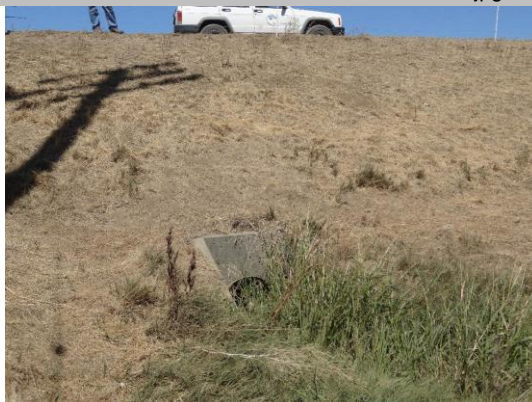
LS view: CM pipe with U shaped concrete headwall. Not accessible. Vegetation is partially blocking inlet pipe.

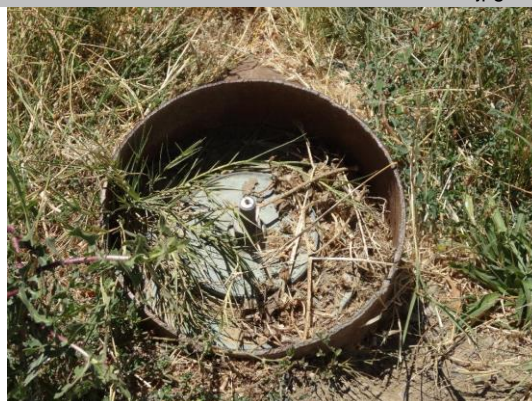
LS view: obstructed siphon breaker in steel riser on levee slope.

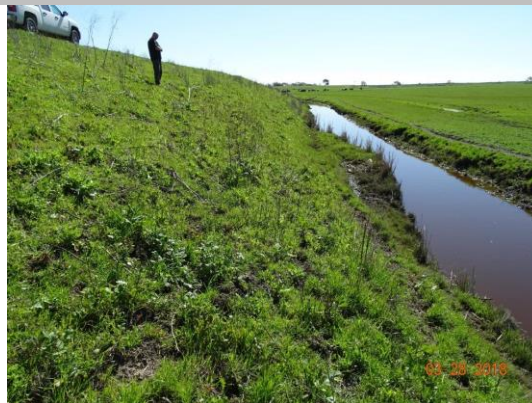
Lower landside slope has slumped into ditch. Should be repaired.

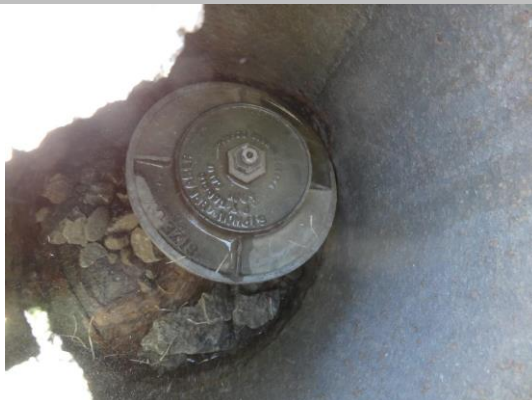
Waterside view: only leaky siphon breaker found.

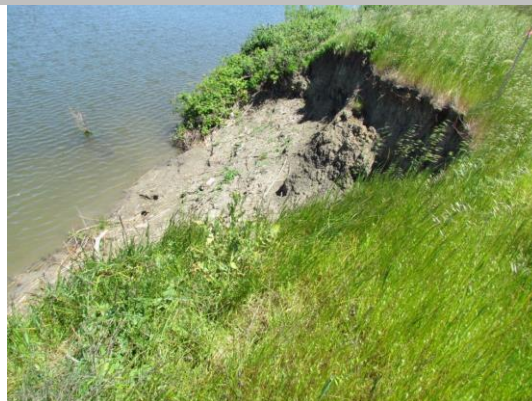
Looking downstream at the erosion in the waterside slope and toe.

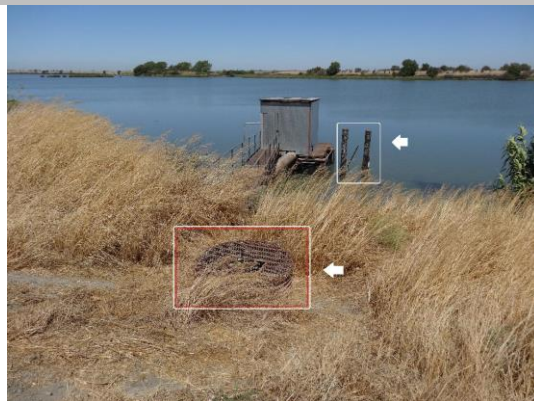
WS view: slide gate in CMP riser (bottom- marked) and may be abandoned pile for pump support (marked- right).

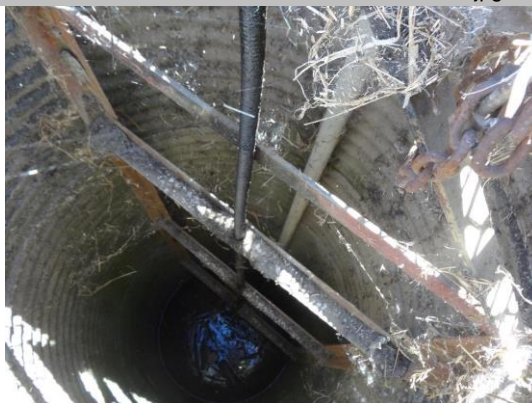
WS view: slide gate and air vent inside CMP riser.
